# Layout Furniture in Supporting the Visually Impaired People at the Dining Area of PSBN Wyata Guna

Deanawati Insani Wasilah & Friska Amalia

Interior Design Department, School of Design,  
Bina Nusantara University, Jakarta, Indonesia 11480

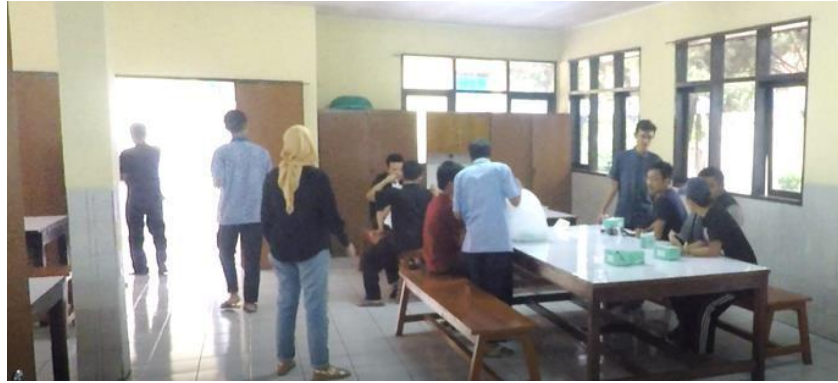
**Figure 6.** The last point visited by the blind person in condition A  
(Wasilah, 2019)

After eating they went out one by one through the exit on the right. From the previous picture, it can be seen that the crowded point on the way to the exit is the point that is around the sound source, here is a picture with only the person points:

After seeing the results above, it can be concluded that the most crowded point in condition A is seat 1A, and the corner of the exit is close to the sound source.

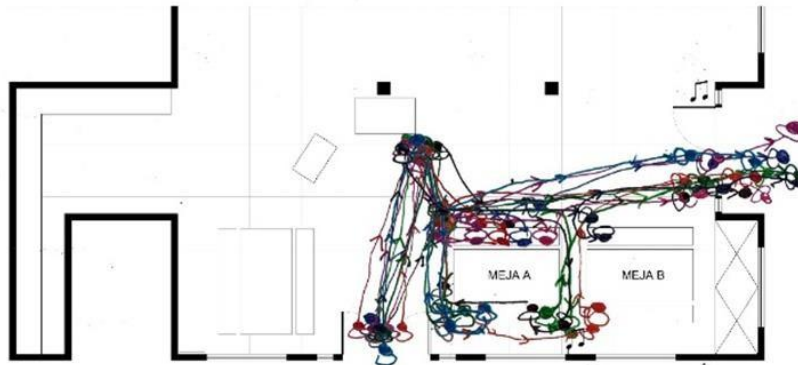
**Figure 7.** Crowd Point and Circulation Condition B  
(Wasilah, 2019)

There are 10 people with visual impairments who are respondents in condition B. In this condition, the sound source is only placed between the two dining tables. The following is the overall circulation and crowd points as well as points for people with visual impairments to sit down to eat at the dining table in condition B:

In this condition, table A is still the most crowded table, but the point of crowding that occurs at the exit has moved to the right side of the door which is close to the dining area. Conditions B and A have differences in the flow towards the dining area, in condition B the respondents tend to look for the dining table while walking towards the first sound source which is between the dining tables, while in condition A the respondents only use the sound as a direction marker. In condition B, there is also the same case as in condition A, namely seat 1A which is the point where people with visual impairments often stop because they hit this chair, for more details, see the picture below:
